Docket No. 217 – Development and Management Plan Inspection

Northeast Utilities Service Company Certificate of Environmental Compatibility and Public Need for the construction of a 345-kV electric transmission line and reconstruction of an existing 115-kV electric transmission line between Connecticut Light and Power Company's Plumtree Substation in Bethel, through the towns of Redding, Weston, and Wilton, and to the Norwalk Substation in Norwalk, Connecticut.

Date: September 15, 2005

Location: Overhead Line (Composite 345kV and 115kV Gallows Hill to Archers Lane)

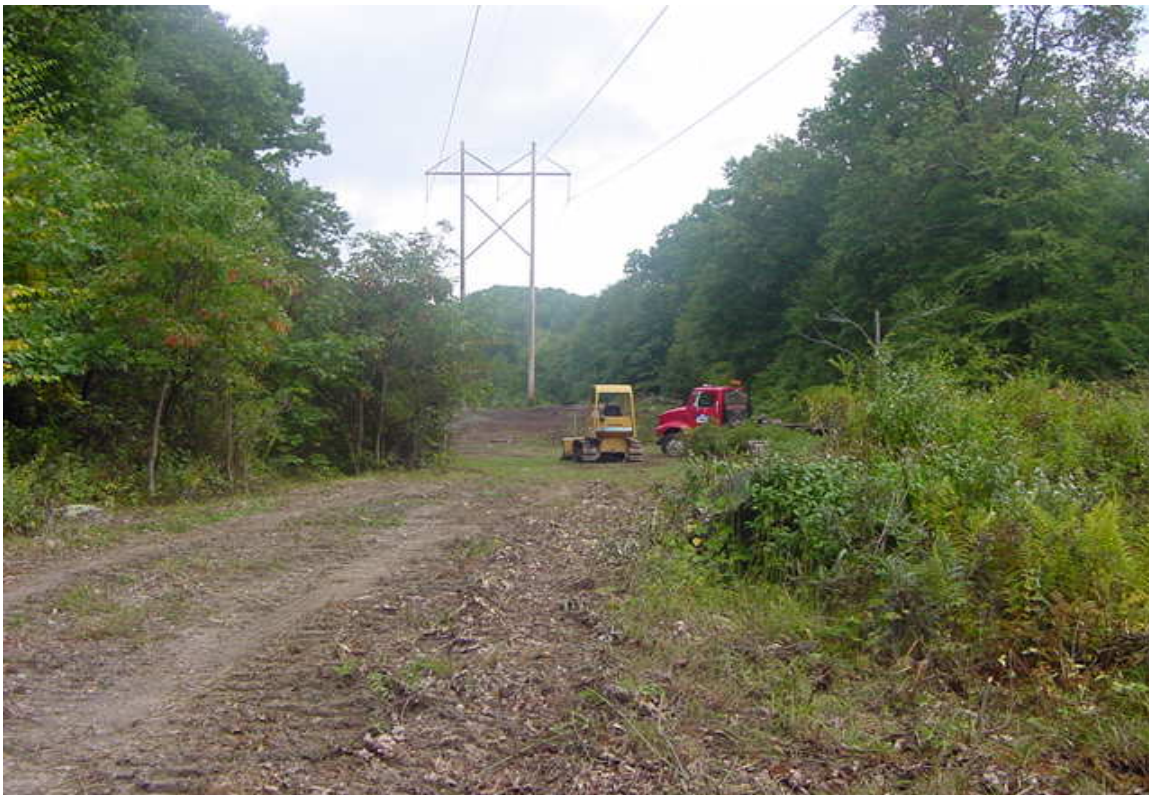
Composite Overhead Transmission Line (Gallows Hill to Archers Lane): Clearing has begun along this section of the right of way in preparation for the line work. (9/15/05)

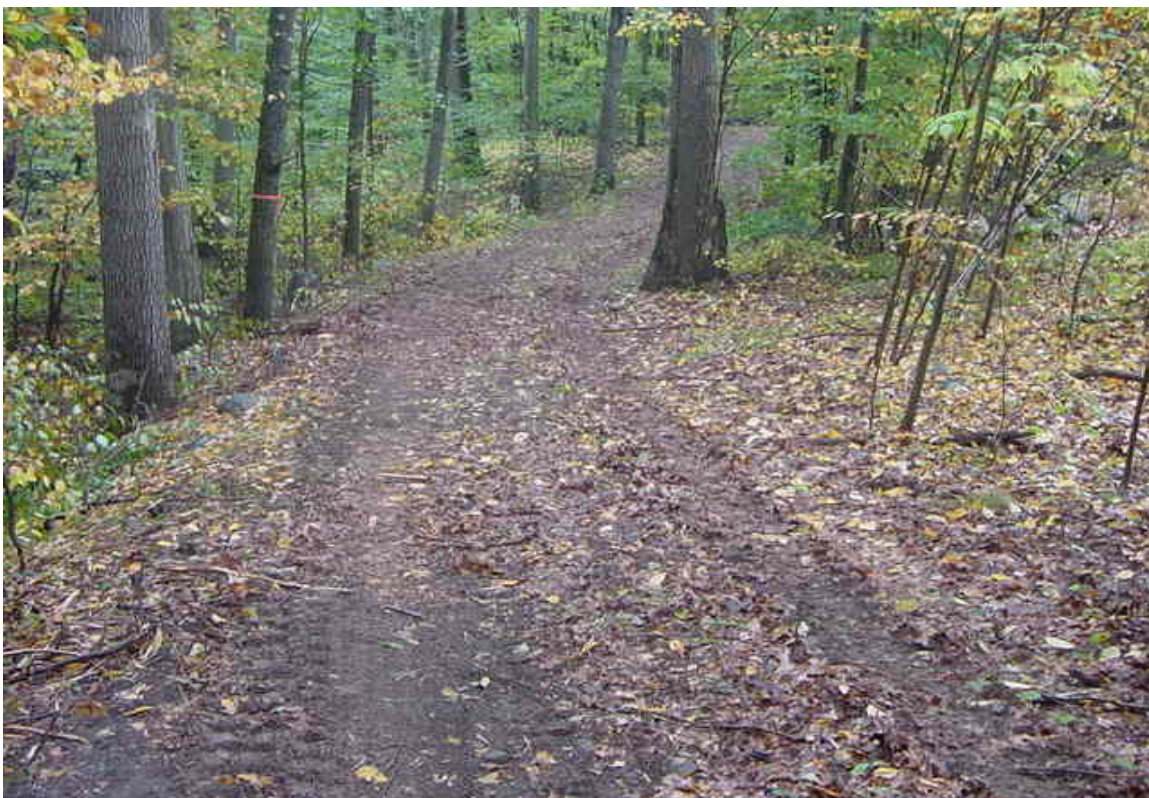
View of an access road where tree limbs had been trimmed for truck access but major clearing was not necessary. (9/15/05)

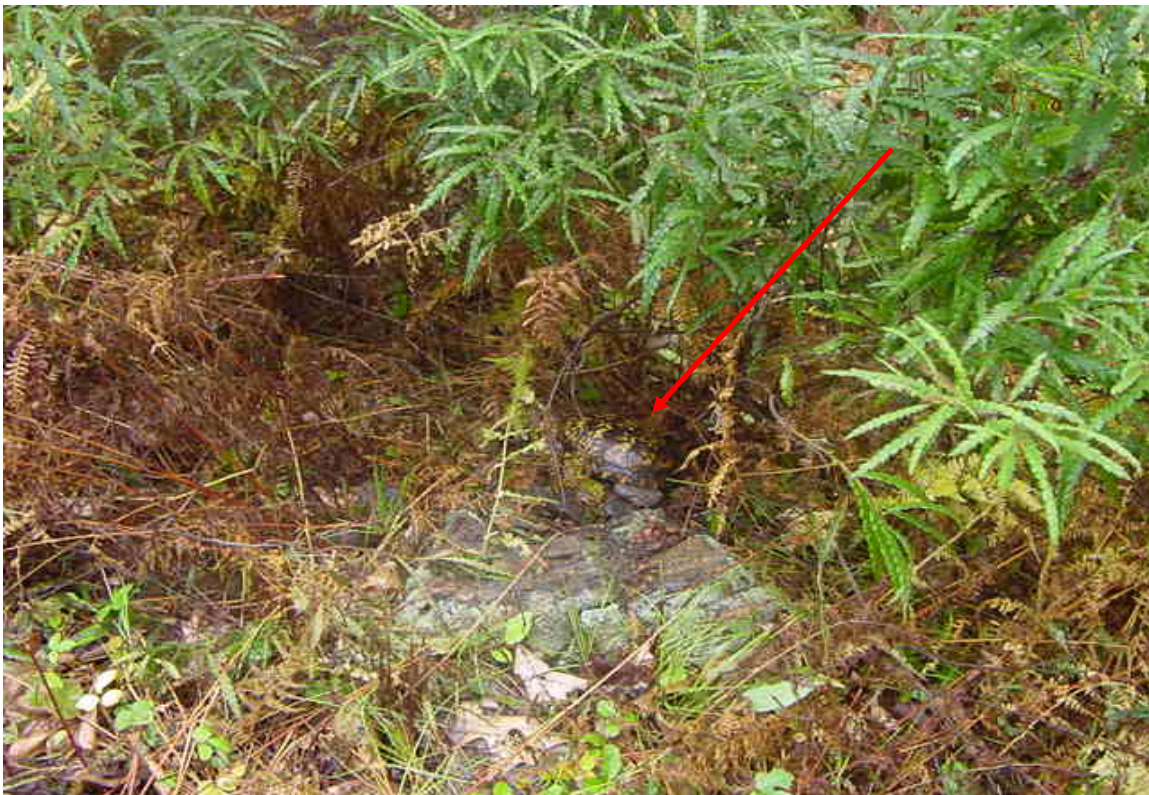
An eastern box turtle (*Terrapene carolina carolina*) was noted in the general vicinity of the ROW. Survey measures should be performed as heavy equipment moves into an area. (9/15/05)

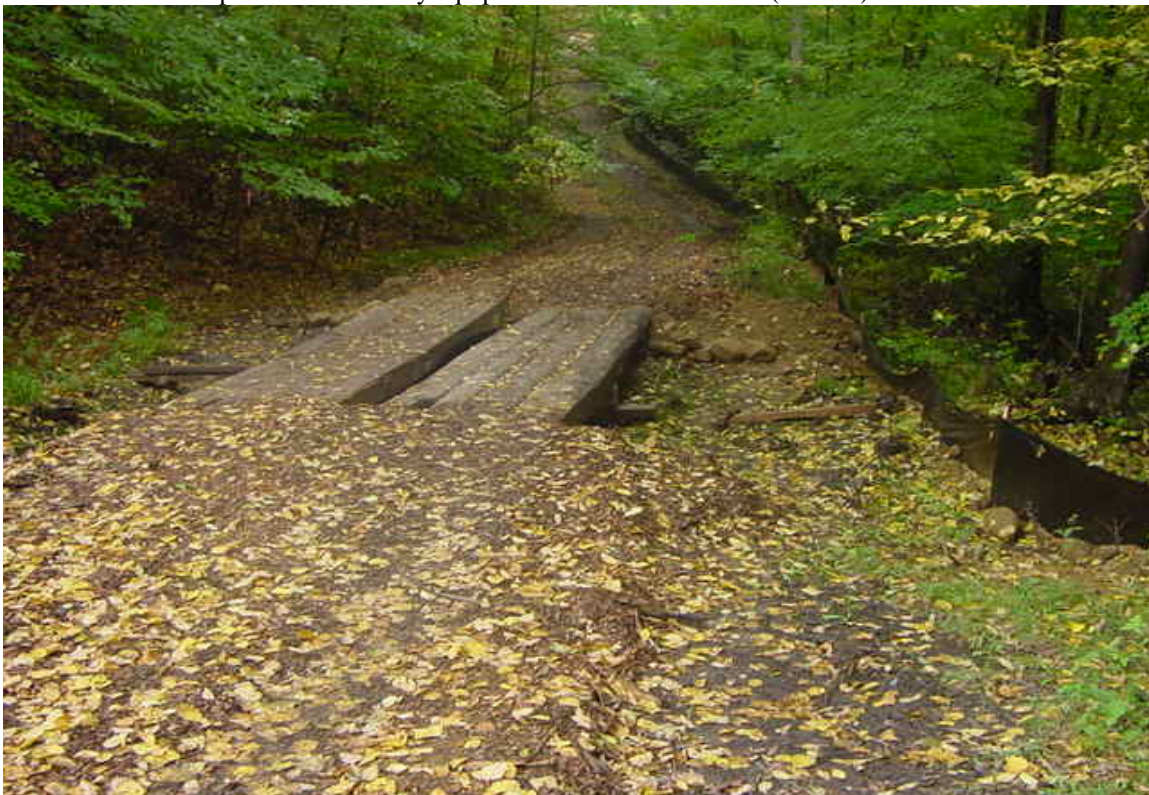
View of the access road near Archers Lane which is permitted for use for the ROW work. A more permanent crossing with a culvert will be constructed under this D&M plan. (9/15/05)
